SIO Shipyard Representative Bi-Weekly Progress Report		
Project: AGOR 28	Contract No.: N00014-12-C-0305	Shipyard: Dakota Creek Industries
Prepared by: Paul D. Bueren Scripps Institution of Oceanography (SIO) 297 Rosecrans St. San Diego, CA 98106	Date: 24 March 2016	Program Officer: Robert (Tim) Schnoor Office of Naval Research 875 Randolph St ONR 321 Arlington, VA 22203-1995
Distribution Statement A: Approved for public release; distribution unlimited.		Report No. A002.096

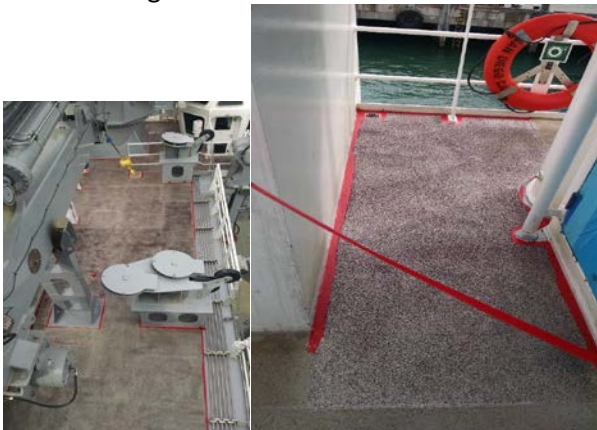
Top coats of paint and nonskid being applied to some of the outside deck areas. Deck was pressure washed following INSURV.

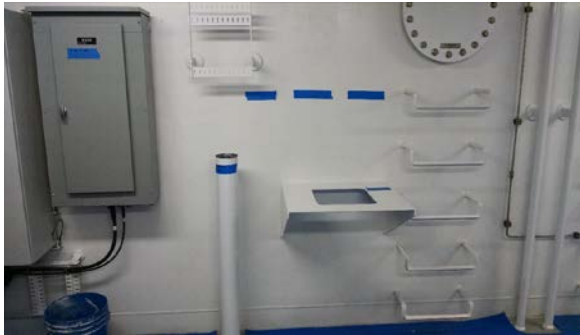
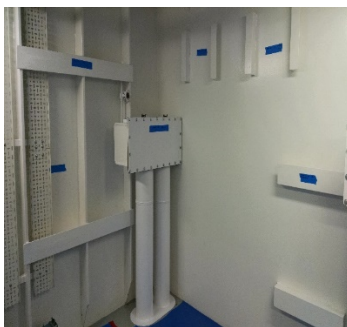
Bench Marks being placed about the decks for Phase III Science Install
Locations Identified and marked in

preparation for Phase III in Transducer spaces

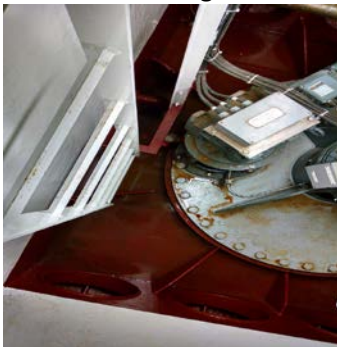
Bow Thruster Bilge still filled with water

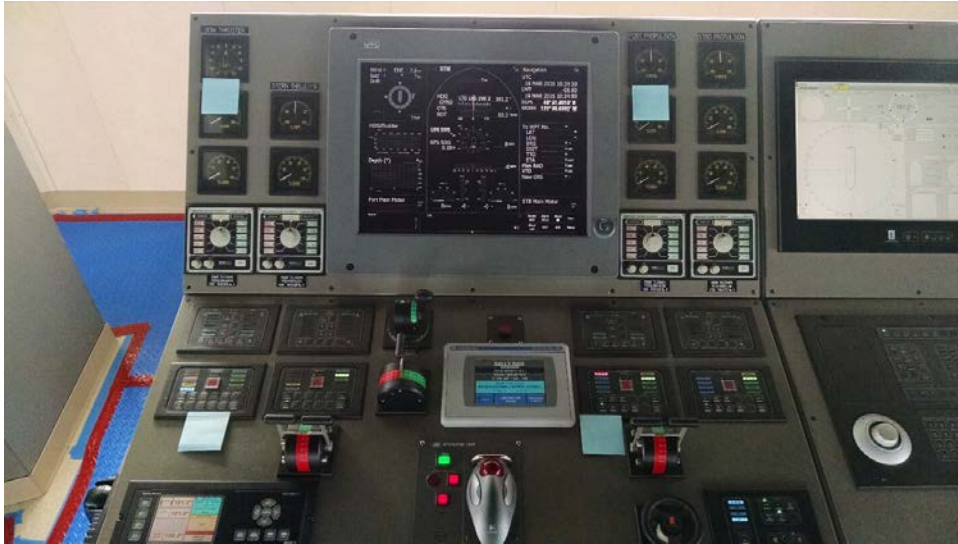
I'd like to ask the yard to rearrange a couple of controls and indicators on the bridge main console. It all works and is installed in accordance with the contract. No additional holes are required. The change would be three gages on the upper left which are bow thruster indications swap with the three gages on the upper right which are port shaft indicators. The control on the left side for the (blue post it) is for

the bow thruster swap with the port propeller control on the right side. The net result would be controls for port side rudder and pitch would be located on the port side of the console aligned with the throttles, engine order telegraph and indicator gages for that shaft. The controls for stbd side rudder and pitch would be located on the stbd side of the console aligned with the throttles, engine order telegraph and indicator gages for that shaft. Tunnel Thruster controls and indicators would remain on the port side of the console, Bow Thruster controls and indicators would now be on the stbd side. Armstrong has expressed interest in this change but it has been some time since we talked about it. They might have grown accustomed to present layout.
